# ORBOST & DISTRICT HISTORICAL SOCIETY INC.

## NEWSLETTER

No. 105 MARCH 2014

### SNOWY RIVER BRIDGE - 1922 to 1934

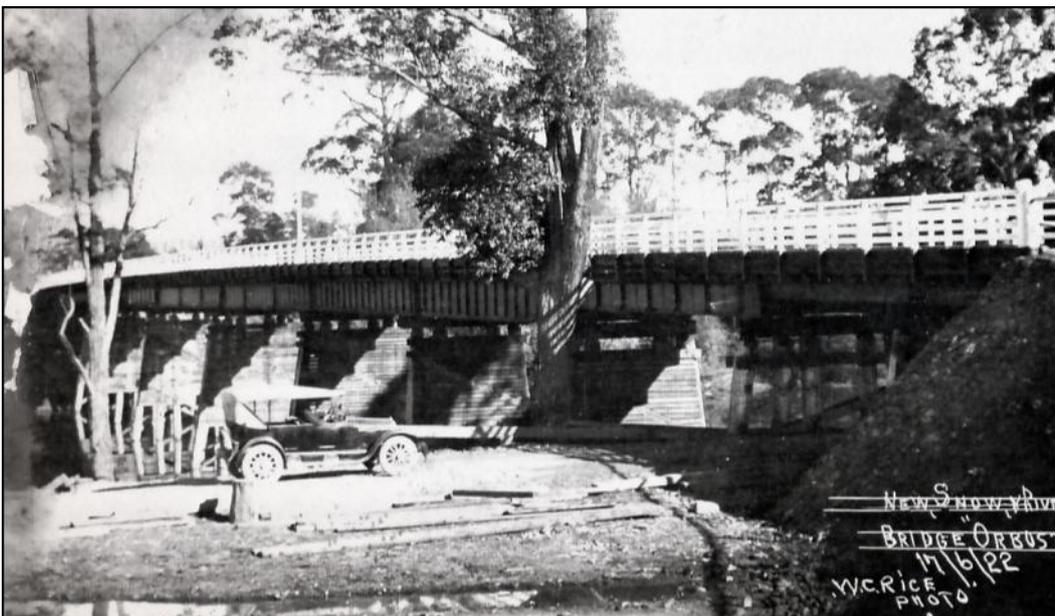
LEFT:

The 1922 bridge soon after its construction.

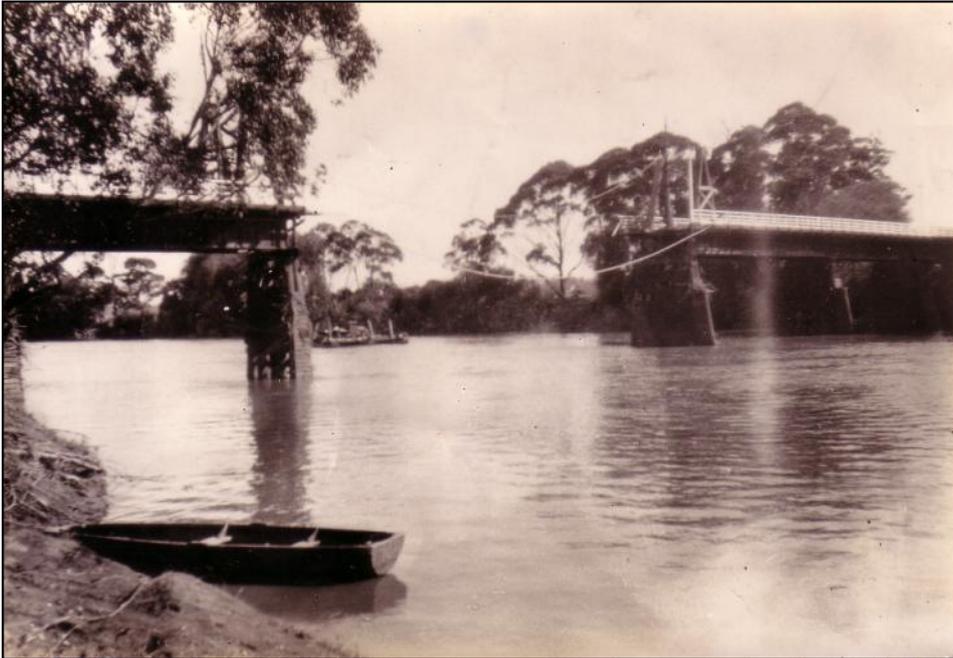
LEFT:

Damage caused by the 1934 flood.

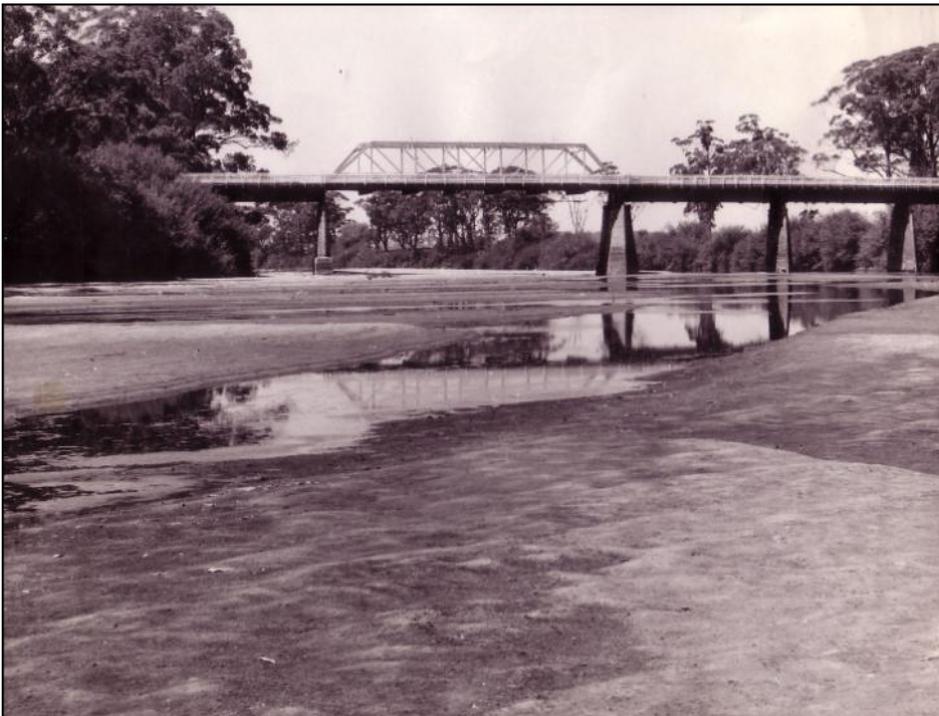
## LEFT:

After the damage of 1934, the bridge was repaired with this new section in the middle. This bridge remained largely unchanged until its final demolition in 1975 after construction of the new concrete bridge and Orbest by-pass which we have today.

This photo was taken during a time of very low water in the river.

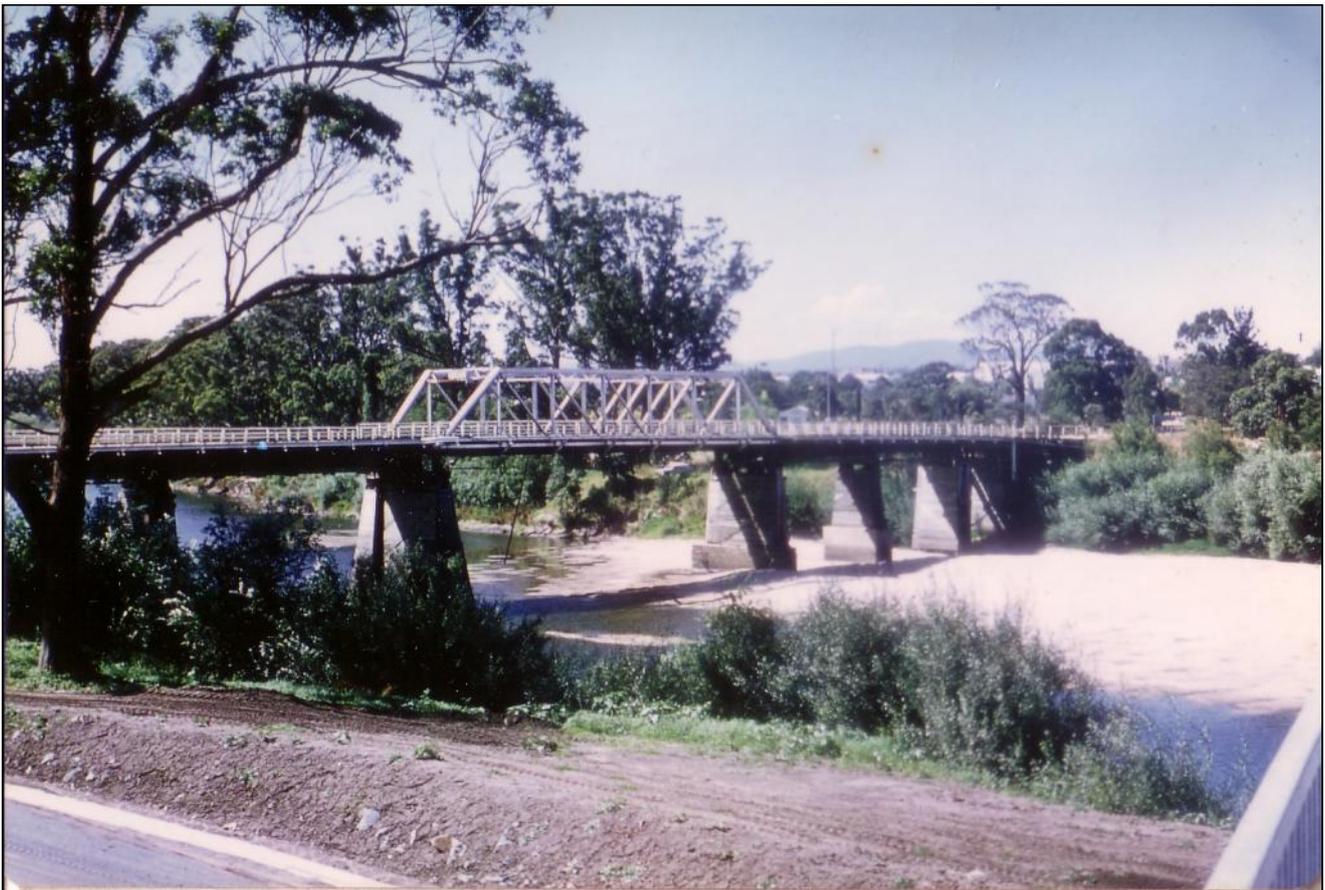
ABOVE: This 1970s image is very near to being the final photo taken of the still largely intact 1922 bridge just before its demolition. At the right of this photo is the railing of the newly completed concrete road bridge and Orbest by-pass. Photo taken from the Newmeralla side.
