ORBOST & DISTRICT HISTORICAL SOCIETY Inc.

NEWSLETTER

No. 130 August 2016

Building the 1970s bridges over the Snowy River and Newmerella floodplain

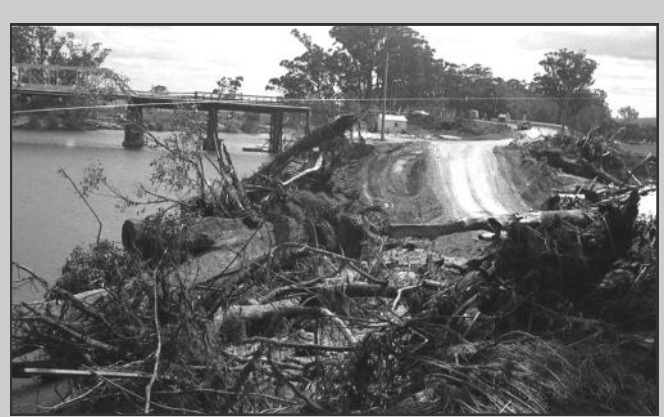
ABOVE: The old bridge after the 1971 flood.

In the 1960s, the Country Roads Board started investigations into creating a new crossing of the Snowy River at Orbost. The existing bridge needed constant maintenance and it was estimated that its lifespan was about a further ten years. The approach alignment at both ends was very poor and fatalities had occurred at the Marlo end. Also, it was common for large vehicles to get stuck under the transverse bracing between the two trusses on the old bridge. Height (and weight) restrictions were imposed. There were strong doubts that the bridge could survive another severe flood.

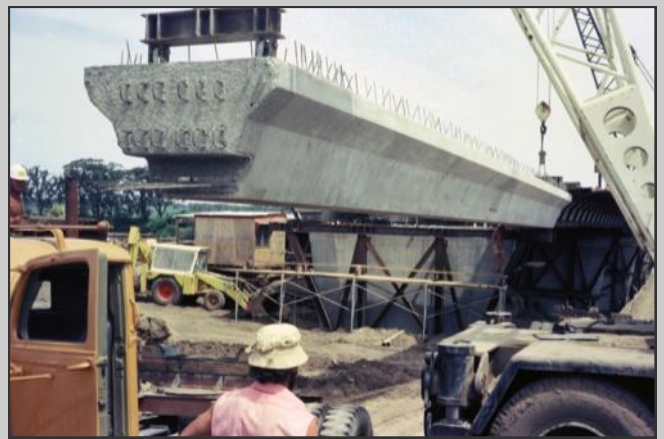
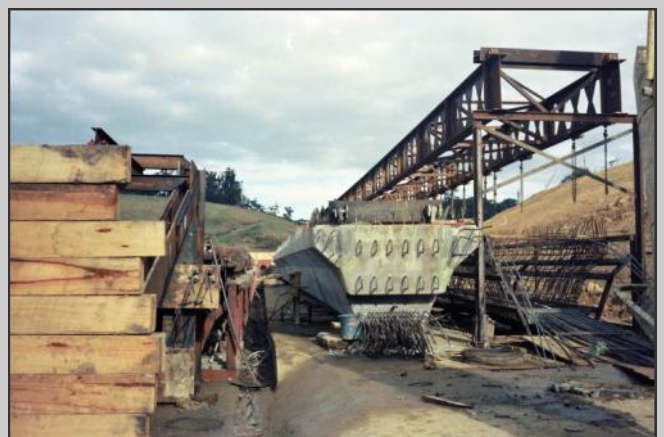
CASTING YARD. A pre-casting yard was set up within the road reserve at the Melbourne end of Ashby’s Gulch at Newmerella, together with two gantries, steam curing, prestressing bed, storage shed and office. Tension piles were located at each end of the casting bed capable of carrying a maximum prestress force of 1000 tons through the wires. After a beam was cast and cured, the wires were cut and the pressure remained in the concrete beam. Steam curing was done overnight with a steam cover over the top. In all, 212 prestressed concrete U beams were made (each 21-30 metres long and weighing up to 50 tons each). Three to four beams per week were produced with a maximum of one per day. Workforce at the casting yard was one foreman, six labourers, and one boiler attendant. After the job was finished, the casting yard was buried. Pearson Bridge P/L was the contractor for this part of the project.

PHOTOS show the construction process for the pre-stressed concrete beams used on all bridge.

David Jellie said “This was the first time that precast U beams had been used by the CRB. The Orbost bridges had a lot of “used first” features that we tried out for the first time. We had a testing laboratory just across from the footie ground (Noel Goldfield was in charge) to test the concrete every morning. The concrete is constantly under compression. No water can get in and there is no cracking so it is maintenance free. We had to produce and store the beams to match what we were doing at the time.”

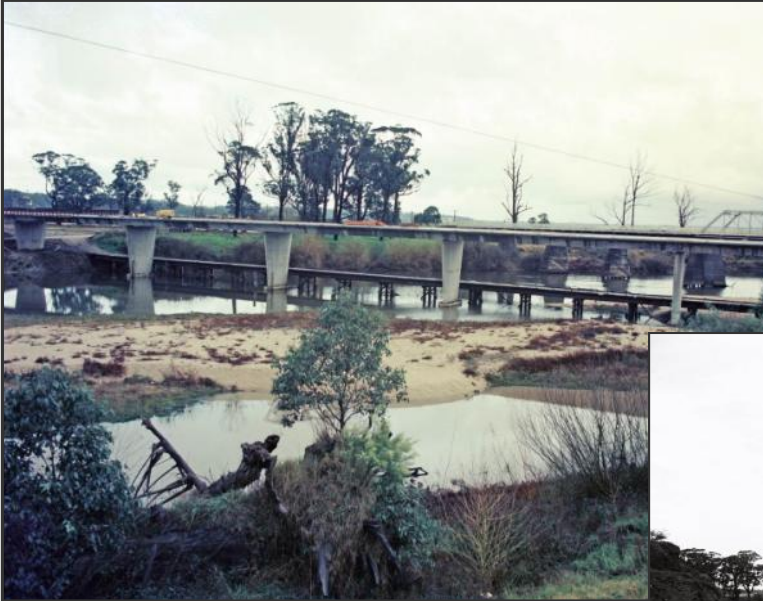
To help in construction of the new bridge across the Snowy River, a low level temporary bridge was built adjacent to the new bridge alignment.

LEFT: In this photo, the new bridge which is under construction can be seen in the foreground. The temporary bridge which was built at a lower level can be seen behind, and further behind is the old bridge.

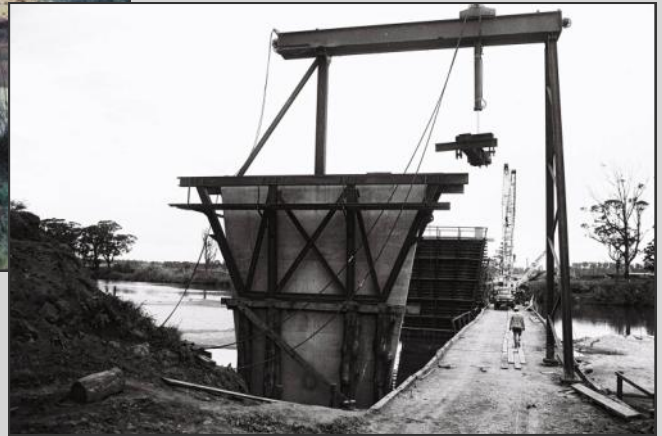
RIGHT: Trucks carrying the massive concrete beams drove on to the temporary low level bridge and the beams were then craned into their correct positions.

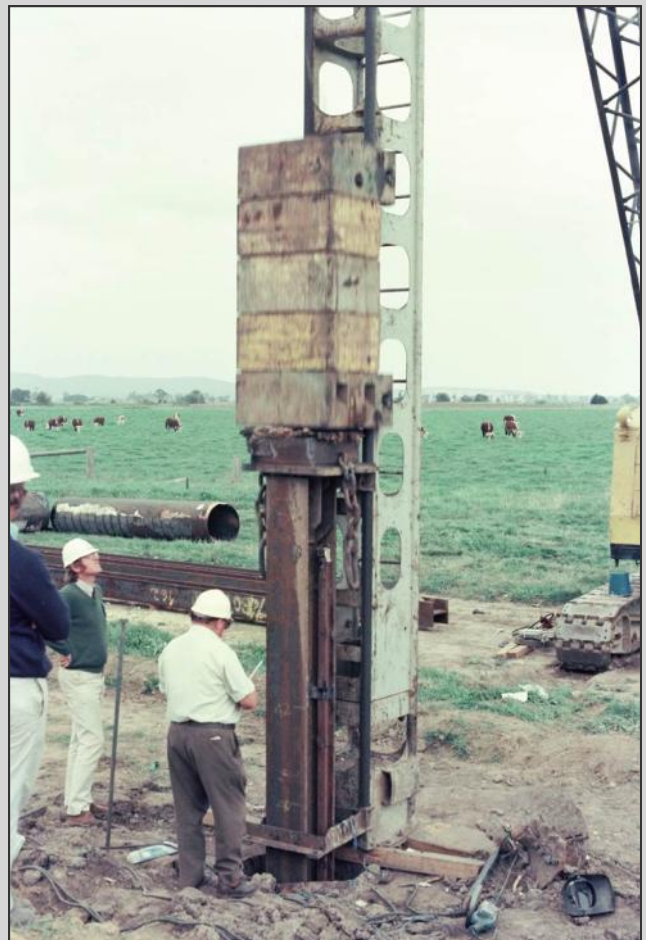
However, at Watt's Gulch, precast concrete Herkules piles were used. Herkules piles come in hexagonal precast sections which are joined together by a locking joint. (See below). The patented mechanical joint is made from steel. The first pile is driven into the ground leaving about 1 metre above ground so that the next section can be fitted and locked in place by turning.

ABOVE: An H-pile being driven into the floodplain silts and gravels. LEFT: Herkules pile joint detail.
